Industry: Chemical & Petrochemical
Application: TCC-Tanks and Chemical Containment Areas

Customer Location: Chemical Plant, Texas U.S.A.
Application Date: November 2008

Substrate: Carbon steel
Products:

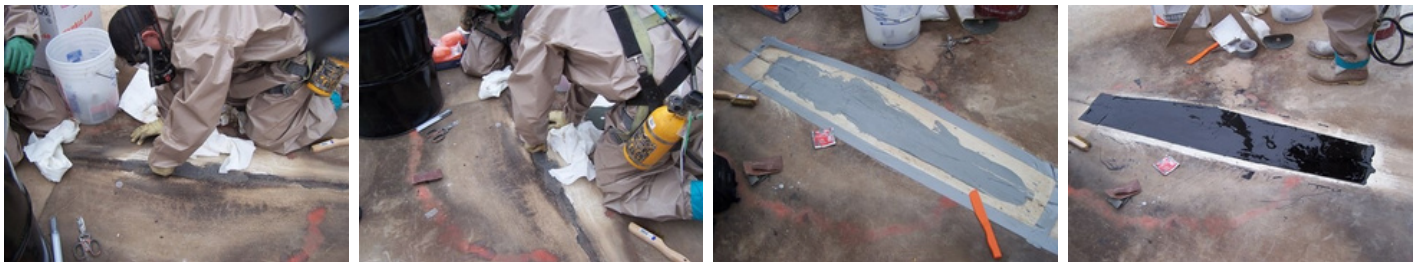
Photograph Descriptions

There was substantial head pressure in the tank resulting in loss of product containment through the corroded seam. This was not only an operations concern, but an environmental and safety issue as well.

* Surface preparation of the seam, * Belzona® 9611 used to stop active leak, * Area taped off and additional leak protection with Belzona® 1221, * Final coating protection with Belzona® 2111,

Overlapped welded plate on floating tank roof was trapping water allowing corrosion.

The active leak was stopped with Belzona® 1291. Repair area leveled with Belzona® 1221. Over-coated taped off area with Belzona® 2111 to provide flexible seal.
